## Site HOTO Report — DHK\_X2119

Project Tiger · Dhaly Infratech → Alliance Computers Limited · Generated 09-Sep-2026 22:11 BD time

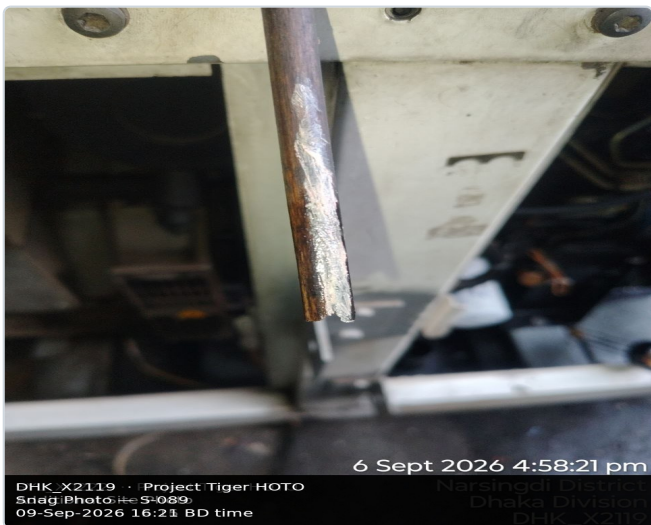
**Photo 2 — S-089 — (from HOTO Telegram group photo  
-- needs review)**

| SNAG # | SYSTEM | CATEGORY | COMPONENT | STATUS | OBSERVATIONS | ACTION | PHOTO |
|---|---|---|---|---|---|---|---|
| S-090 | General | — | (from HOTO Telegram group photo -- needs review) | Faulty | Auto-tagged as Snag from imported chat photo; please fill in the actual system/category/observation. | Open | |

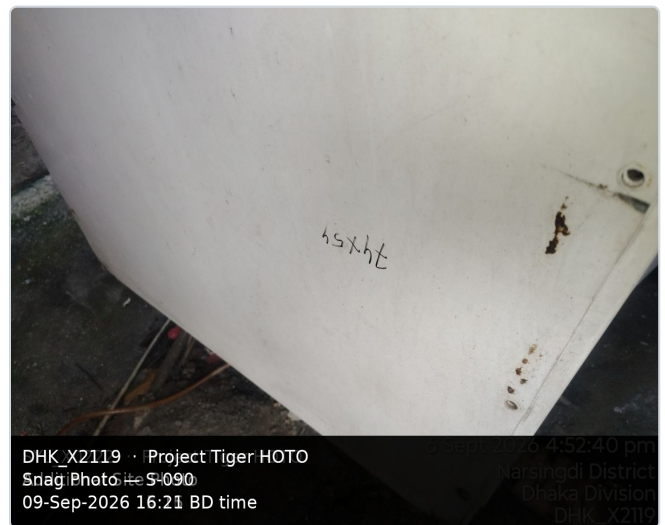
**Photo 3 — S-090 — (from HOTO Telegram group photo  
-- needs review)**

| SNAG # | SYSTEM | CATEGORY | COMPONENT | STATUS | OBSERVATIONS | ACTION | PHOTO |
|---|---|---|---|---|---|---|---|
| S-091 | General | — | (from HOTO Telegram group photo -- needs review) | Faulty | Auto-tagged as Snag from imported chat photo; please fill in the actual system/category/observation. | Open | |

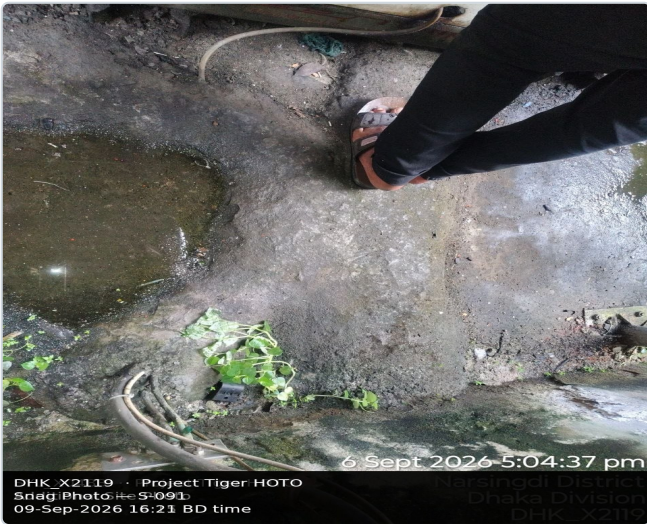
**Photo 4 — S-091 — (from HOTO Telegram group photo -- needs review)**

### DEFICIENCIES & SAFETY REMARKS
