## Site HOTO Report — DHK\_X5584

Project Tiger · Dhaly Infratech → Alliance Computers Limited · Generated 09-Sep-2026 04:45 BD time

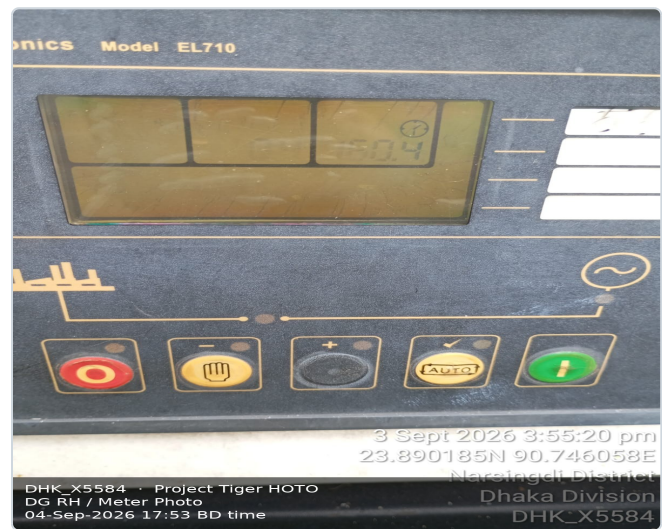
**Photo 2 — DG RH / Meter**

| FUEL TANK CAPACITY | 1000 | PRESENT RH | 4160.4 |

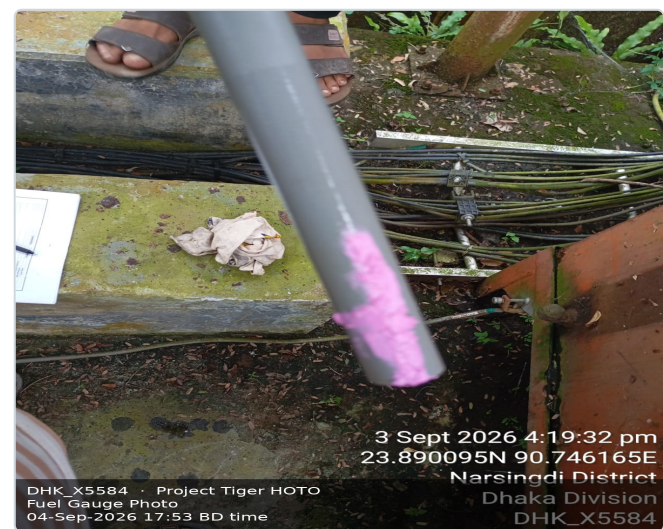
**Photo 3 — Fuel Gauge**

| FUEL (NO WATER) | 107.6 L | FUEL (TOTAL) | 107.6 L |

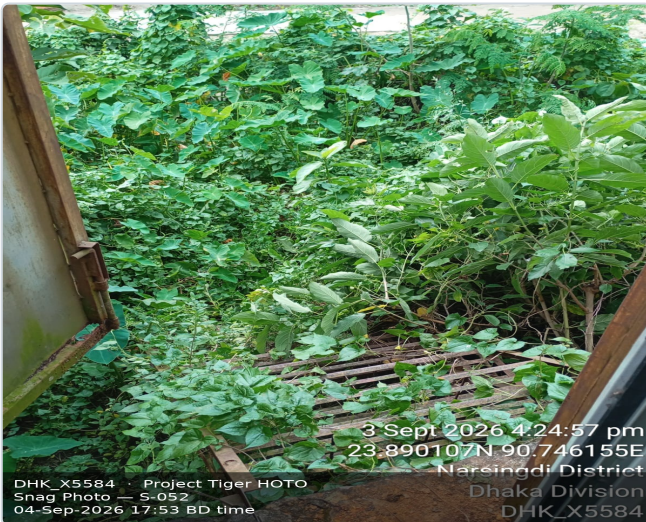
Photo 4 — S-052 — Site Cleaning Status

| ITEM | VALUE | ITEM | VALUE |
|---|---|---|---|
| Site Cleaning Status | NOK | | |

| SNAG # | SYSTEM | CATEGORY | COMPONENT | STATUS | OBSERVATIONS | ACTION | PHOTO |
|---|---|---|---|---|---|---|---|
| S-052 | General | Site Cleanliness/Bush | Site Cleaning Status | Faulty | Need Bush Clean | Open | |
