## Site HOTO Report — SYL\_G0420

Project Tiger · Dhaly Infratech → Alliance Computers Limited · Generated 09-Sep-2026 00:10 BD time

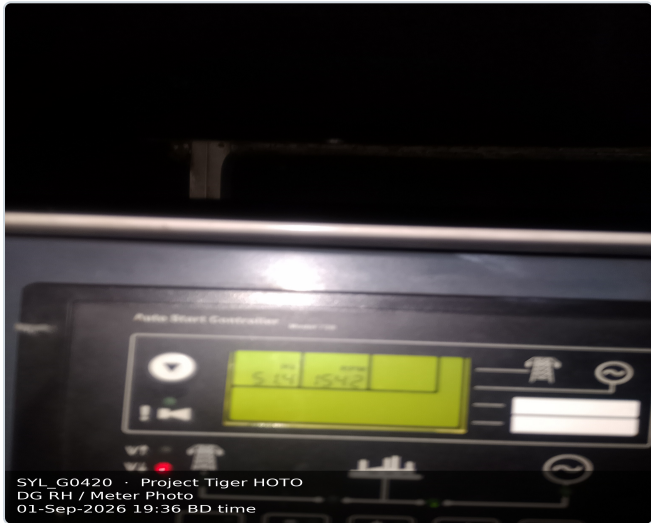
**Photo 2 — DG RH / Meter**

| FUEL TANK CAPACITY | 2000 | PRESENT RH | 3498.4 |

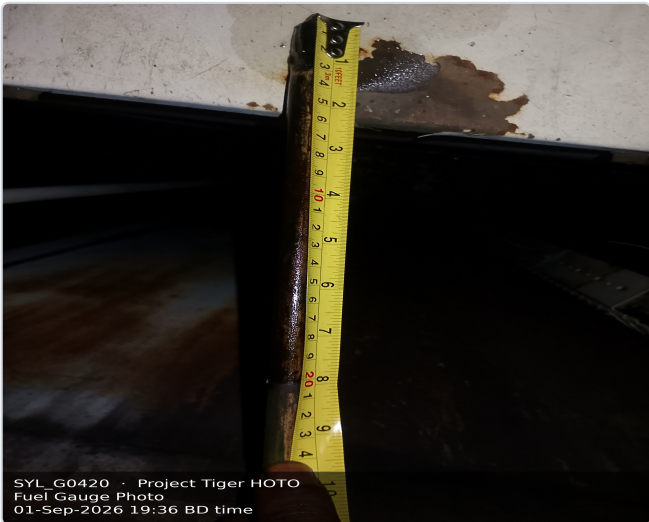
**Photo 3 — Fuel Gauge**

| FUEL (NO WATER) | 178 L | FUEL (TOTAL) | 297 L |
| WATER AMOUNT | 119 L | FUEL AMOUNT (WORD) | One Hundred Seventy Eight Li |

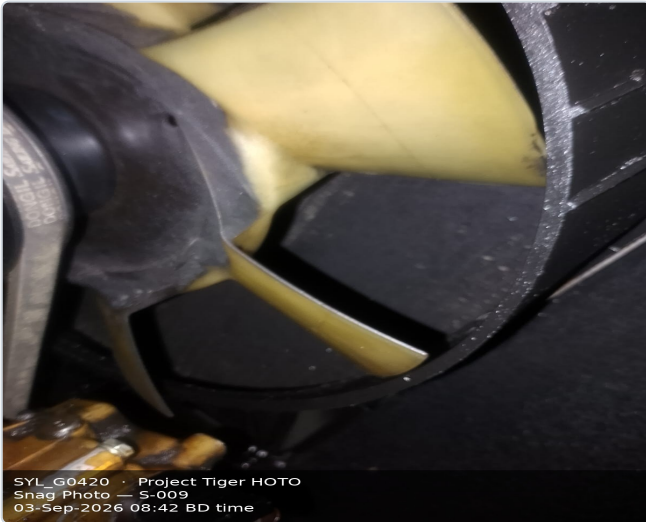
**Photo 4 — S-009 — Radiator fully block dust**

| ITEM | VALUE | ITEM | VALUE |
|---|---|---|---|
| DG Radiator Condition | NOK | DG Battery Condition | OK |

| SNAG # | SYSTEM | CATEGORY | COMPONENT | STATUS | OBSERVATIONS | ACTION | PHOTO |
|---|---|---|---|---|---|---|---|
| S-009 | DG | DG - Other | Radiator fully block dust | Faulty | — | Open | |

| GENERAL REMARKS | 1) Hedgasket problem 2) Rediator jum/ not cilin |
