## Site HOTO Report — DHK\_X5181

Project Tiger · Dhaly Infratech → Alliance Computers Limited · Generated 07-Sep-2026 20:53 BD time

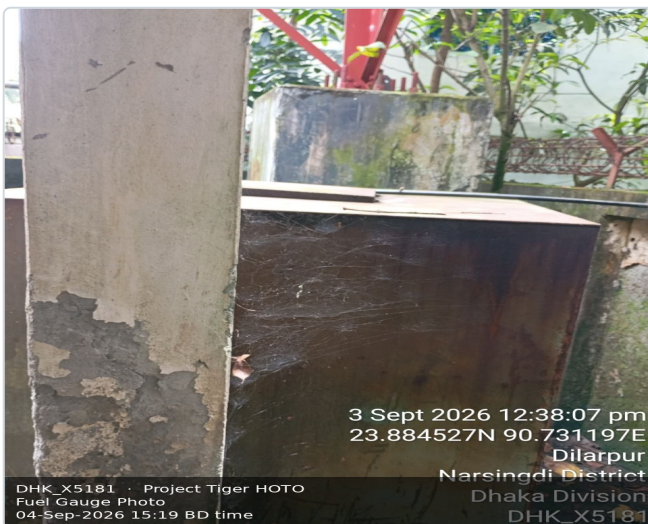
Photo 3 — Fuel Gauge

| FUEL (NO WATER) | 365 L | FUEL (TOTAL) | 379 L |
| WATER AMOUNT | 14 L | FUEL AMOUNT (WORD) | Three Hundred Seventy Nine Liters |
