## Site HOTO Report — SYL\_G0397

Project Tiger · Dhaly Infratech → Alliance Computers Limited · Generated 09-Sep-2026 02:12 BD time

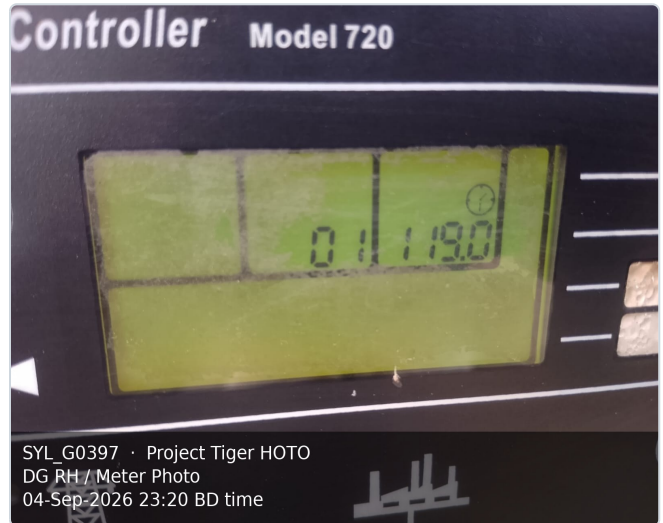
**Photo 2 — DG RH / Meter**

| FUEL TANK CAPACITY | 2000 | PRESENT RH | 1119 |
| RH METER TYPE | Digital from controller | LAST SERVICE DATE | 2026-02-17 |

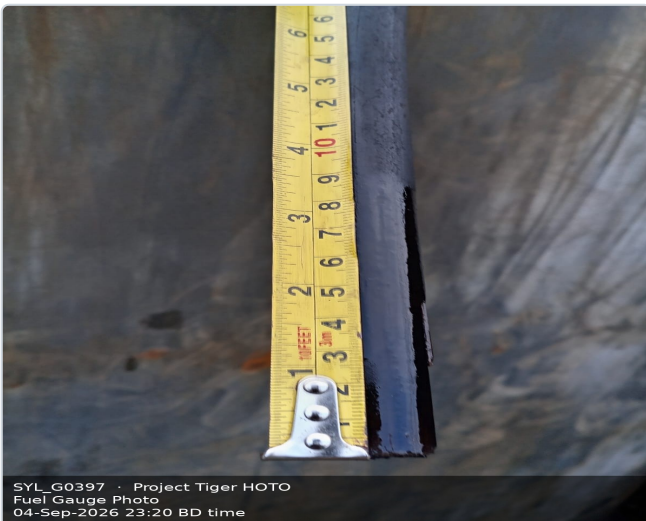
**Photo 3 — Fuel Gauge**

| FUEL (NO WATER) | 124 L | FUEL (TOTAL) | 124 L |

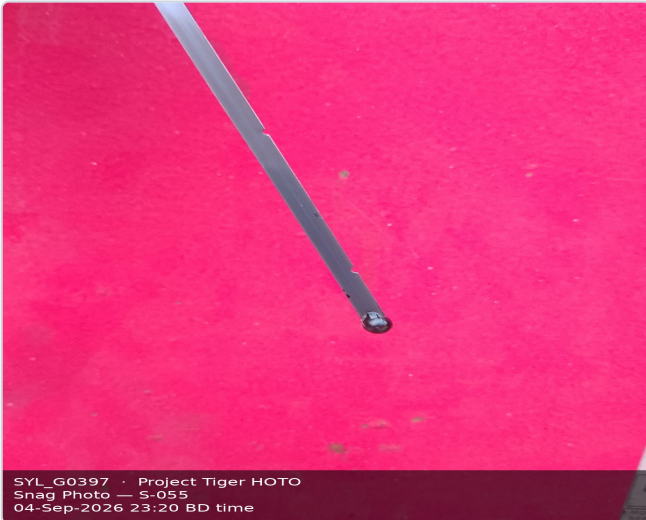
| ITEM | VALUE | ITEM | VALUE |
|---|---|---|---|
| Lub Oil Status (Level & Colour) | NOK | DG RH Meter Working Properly | OK |

| SNAG # | SYSTEM | CATEGORY | COMPONENT | STATUS | OBSERVATIONS | ACTION | PHOTO |
|---|---|---|---|---|---|---|---|
| S-055 | DG | DG - Other | DG lube oil empty | Faulty | — | Open | |

**Photo 4 — S-055 — DG lube oil empty**

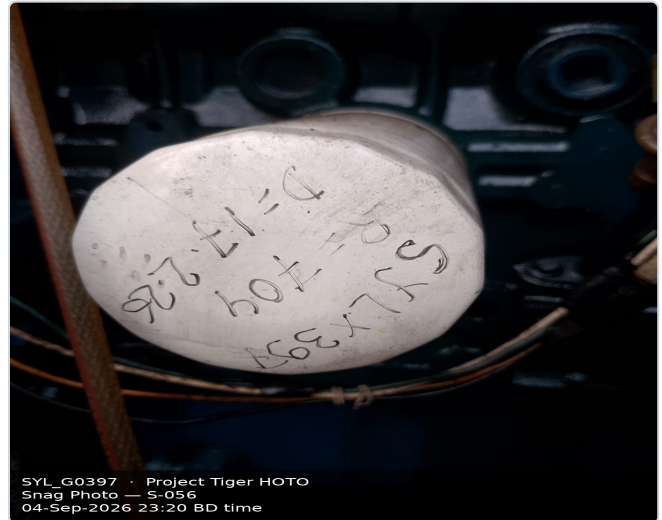
| SNAG # | SYSTEM | CATEGORY | COMPONENT | STATUS | OBSERVATIONS | ACTION | PHOTO |
|---|---|---|---|---|---|---|---|
| S-056 | DG | DG - Other | servicing date run hour over | Faulty | — | Open | |

**Photo 5 — S-056 — servicing date run hour over**

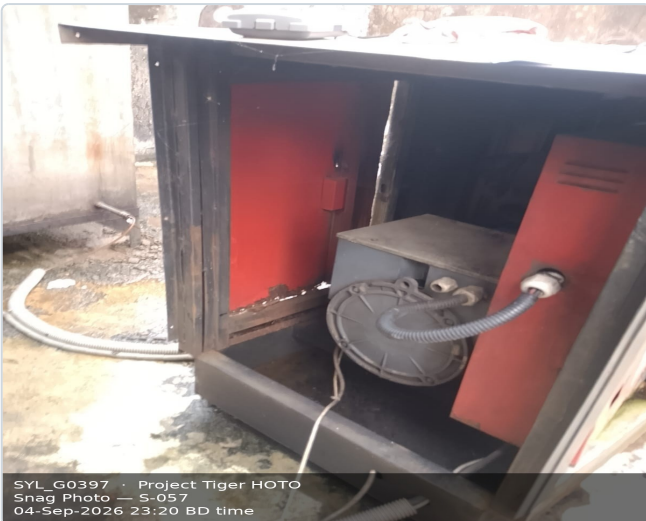
| SNAG # | SYSTEM | CATEGORY | COMPONENT | STATUS | OBSERVATIONS | ACTION | PHOTO |
|---|---|---|---|---|---|---|---|
| S-057 | DG | DG - Other | Font site canopy missing | Faulty | — | Open | |

**Photo 6 — S-057 — Font site canopy missing**

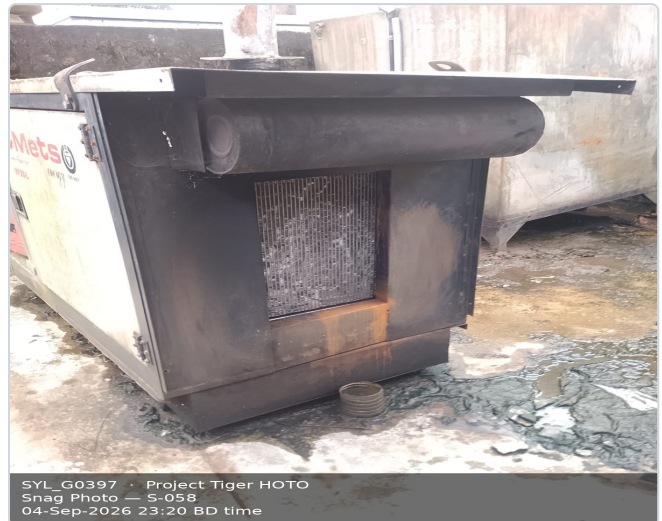
| SNAG # | SYSTEM | CATEGORY | COMPONENT | STATUS | OBSERVATIONS | ACTION | PHOTO |
|---|---|---|---|---|---|---|---|
| S-058 | DG | DG - Other | DG back site canopy missing | Faulty | Charging dynamo faulty | Open | |

**Photo 7 — S-058 — DG back site canopy missing**

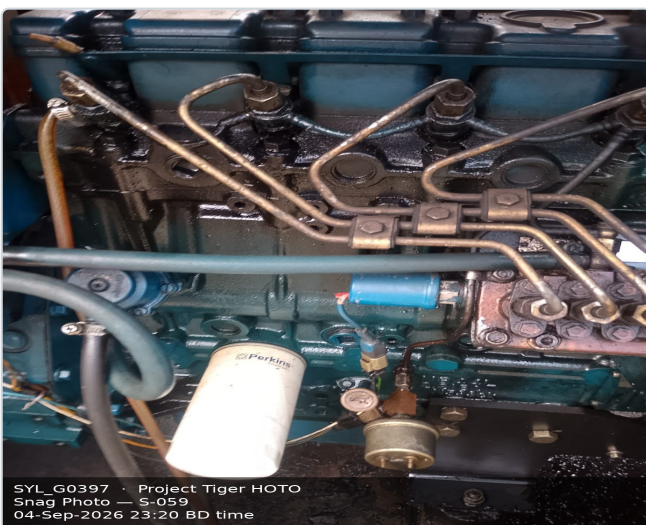
| S-059 | DG | DG - Other | Need to overhaling | Faulty | — | Open | |

**Photo 8 — S-059 — Need to overhaling**
