## Site HOTO Report — SYL\_X0274

Project Tiger · Dhaly Infratech → Alliance Computers Limited · Generated 26-Oct-2026 11:57 BD time

### SITE & HANDOVER DETAILS

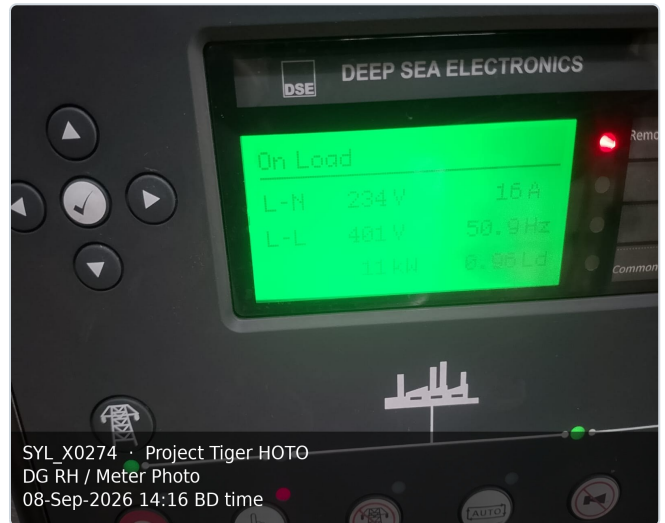
Photo 2 — DG RH / Meter

| FUEL TANK CAPACITY | 2000 | PRESENT RH | 966.50 |
| RH METER TYPE | Digital from controller | LAST SERVICE DATE | — |

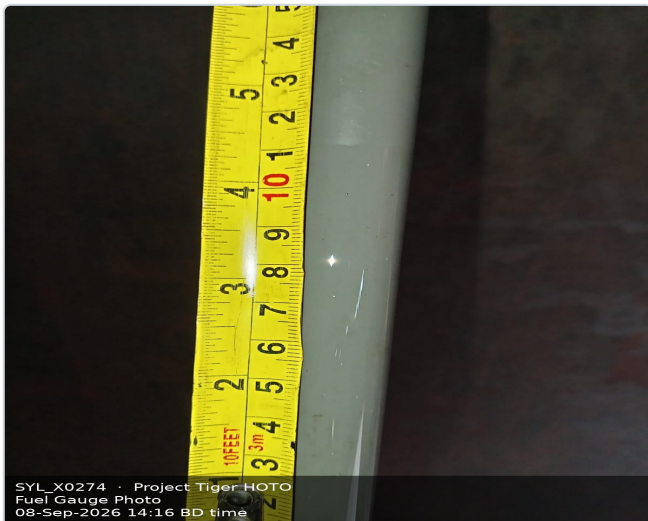
| FUEL (NO WATER) | 127 L | FUEL (TOTAL) | 164 L |
| WATER AMOUNT | 37 L | FUEL AMOUNT (WORD) | One Hundred Sixty Four Liters |

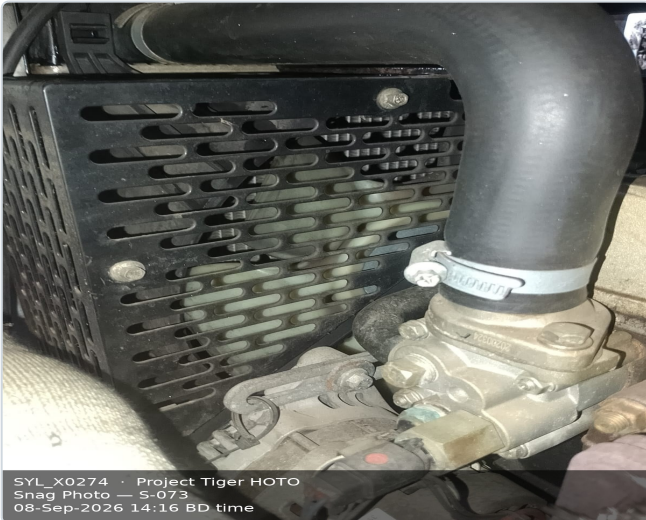
| ITEM | VALUE | ITEM | VALUE |
|---|---|---|---|
| DG Radiator Condition | NOK | DG Battery Condition | OK |

| SNAG # | SYSTEM | CATEGORY | COMPONENT | STATUS | OBSERVATIONS | ACTION | PHOTO |
|---|---|---|---|---|---|---|---|
| S-073 | DG | DG - Other | The radiator is full of dust | Faulty | — | Open | |

| DG MAJOR DEFICIENCIES | Radiator not clean, needs servicing |

**Photo 4 — S-073 — The radiator is full of dust**

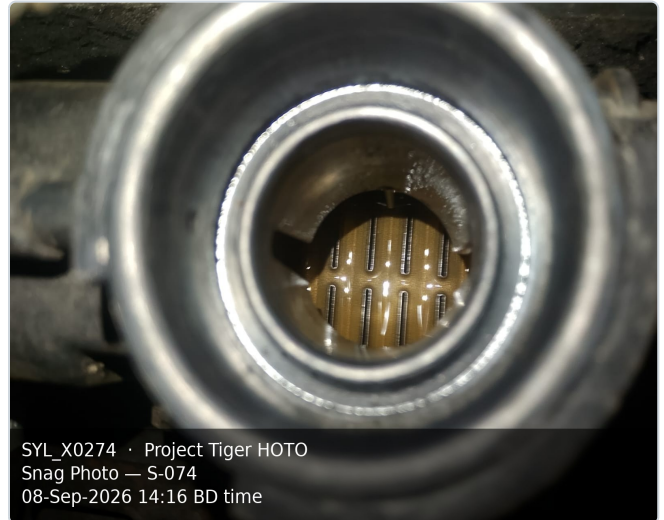
| SNAG # | SYSTEM | CATEGORY | COMPONENT | STATUS | OBSERVATIONS | ACTION | PHOTO |
|---|---|---|---|---|---|---|---|
| S-074 | DG | DG - Other | No water in site radiator | Faulty | — | Open | |

**Photo 5 — S-074 — No water in site radiator**
